Decision support system for countermeasures in cruise ship flooding case

Thesis submitted in partial fulfillment of the requirement for
the degree of Master of Science in Technology.

Espoo 24.7.2018

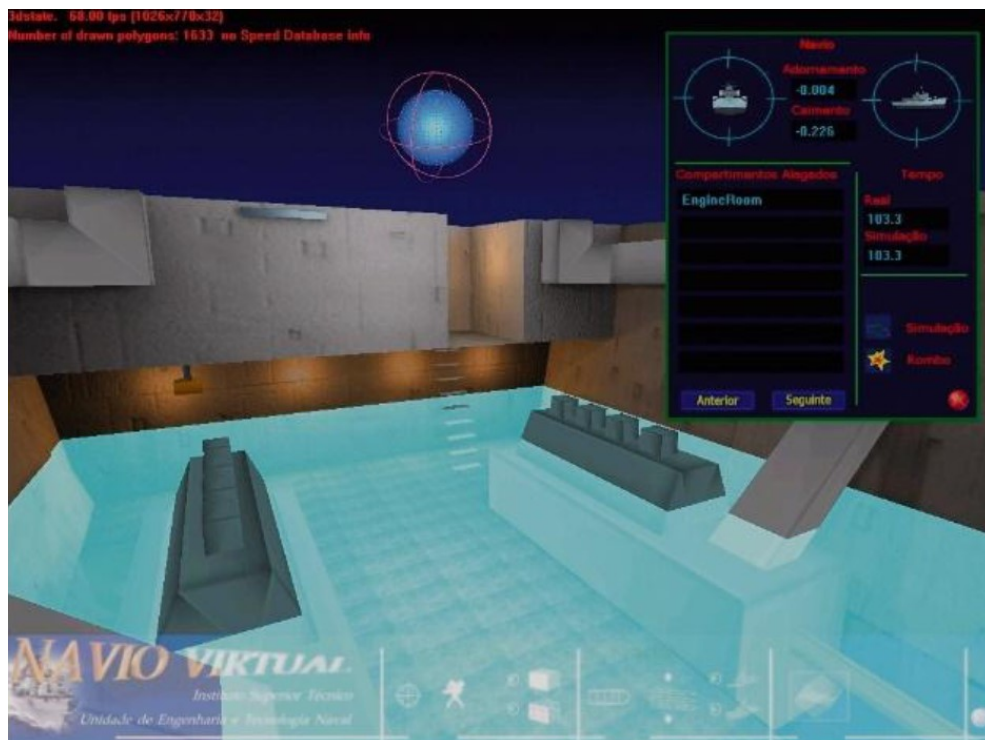
Figure 2.3 Visualization of flooding in an engine room by Varela & Guedes Soares (2014).

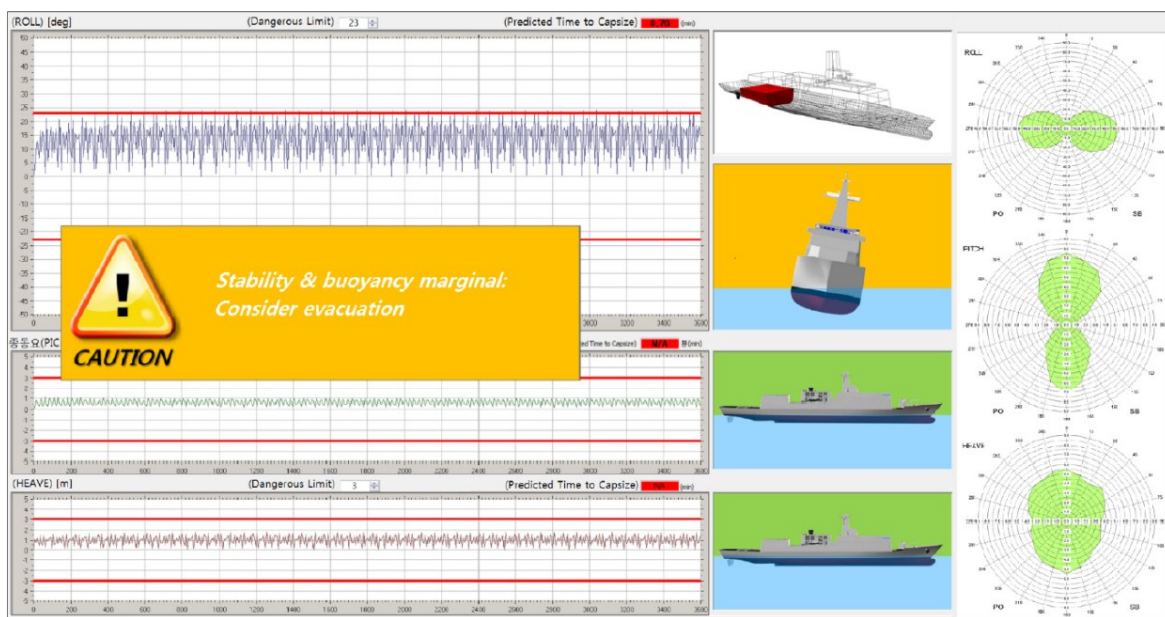
Figure 2.7 Motional graphs and polar charts by Choi et al. (2014).

When the system is in use on board, damage can be defined manually or it can be read from ship's flooding sensors. Wave conditions such as heading and height should be known as well but the paper does not discuss how these are obtained. Based on pre-stored data, current damage suffered and current wave conditions, the system will evaluate the level of danger and present the safety status of the vessel with a red, yellow or green indicator. More detailed information about the situation is available in form of motional graphs of e.g. rolling angle and a time-domain prediction about how the situation will progress. This prediction can be used as an aid to decide about the evacuation of the vessel. Also polar charts are plotted to display ship motions in different wave heading angles. The polar charts can be used to align the vessel correctly to avoid excessive rolling motions which could capsize the ship. These features are presented in Figure 2.7.

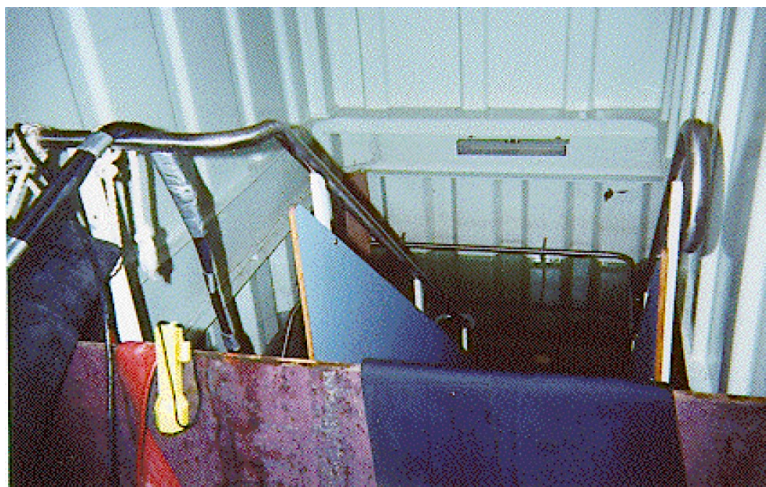
Figure 3.1 Welded steel plate to prevent up-flooding from a stairwell on board Monarch of the Seas (USCG 2003).

One accident where up-flooding of the ingress water had been actively tried to be prevented is the grounding of cruise ship *Monarch of the Seas* in 1998 in the Netherlands Antilles. The ship hit a reef causing damage to about half of the double bottom tanks and a few compartments on tank top. Watertight doors were closed after which up-flooding was tried to be prevented by closing escape hatches in two damaged rooms. Also a steel plate to prevent up-flooding was welded in one staircase where water was about to rise on the bulkhead deck visible in Figure 3.1. These actions most probably slowed down the progress of floodwater inside the ship and gave more time for evacuation. Before the flooding escalated on the bulkhead deck the Master decided to ground the ship on a shallow sandbar. (USCG 2003)

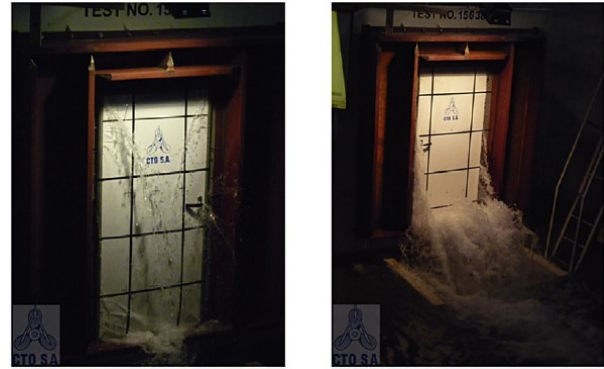
Figure 4.1 Full scale tests conducted by Jalonen et al. (2017) to measure leaking and collapsing characteristics of non-watertight doors.

Leaking area ratio was dependent on the loading direction of the door and in some cases also on the pressure head. It was found to be at maximum about 0.05 which means that closing a fire door can suppress the flooding rate to 5 % compared to an open door. This is a very significant result justifying the effect of closing fire doors to prevent progressive flooding. Collapsing of the doors happened between 1 to 3.5 meters pressure head and it was independent of the loading direction. Figure 4.1 depicts the leaking area ratio results for A-class hinged fire doors and leaking of the doors.
